December 12, 2025

Preliminary Engineering Assessment of Damage to a Building

Location: 76 West Avenue North, Hamilton, Ontario

Our File No.: 2512-1101-BP

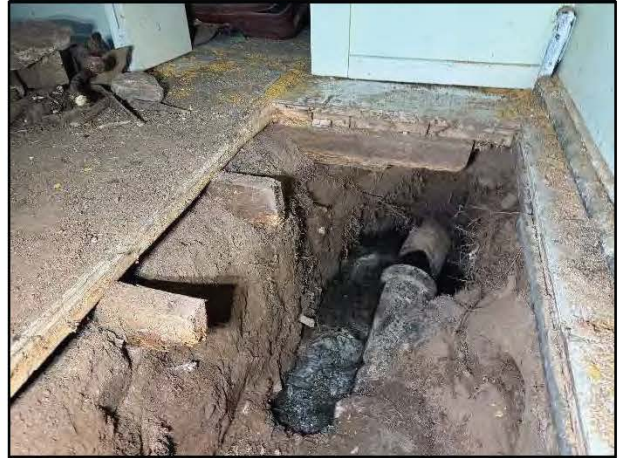
1) Sewer Pipe in Basement

A sewer pipe was exposed and locally fractured, with effluent present within the excavated pit. Strong sewer gas was noted immediately upon entering the basement unit. The sewer pipe was reported to be shared with the neighbouring building. We recommend the sewage pipe be repaired immediately by a qualified plumbing contractor. The condition presented a health hazard due to sewage and sewer gas exposure.

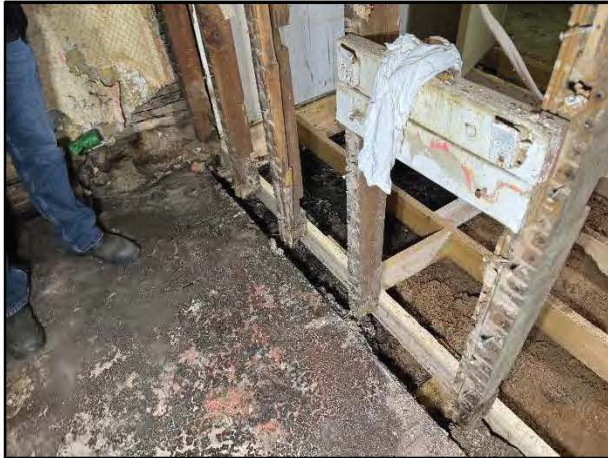
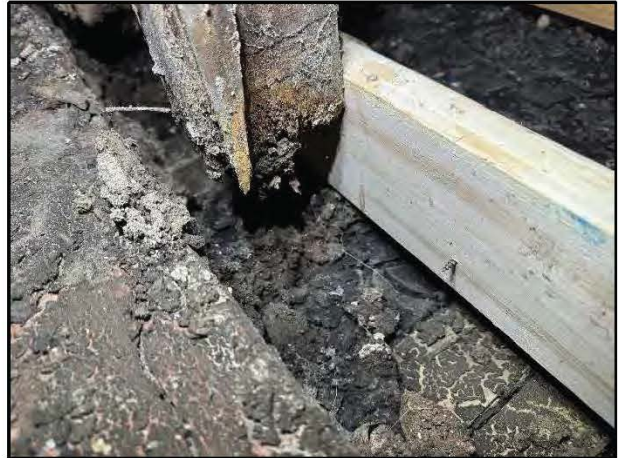
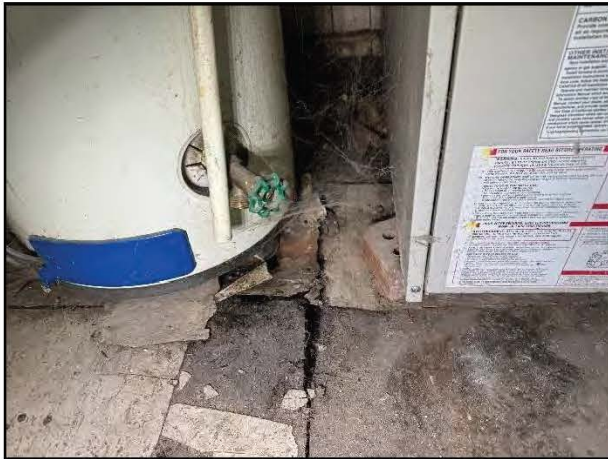
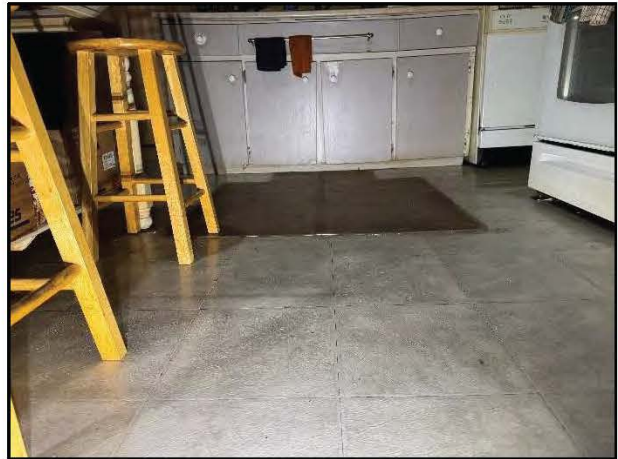
2) Intermediate Load Bearing Wall in Basement

An intermediate load bearing wall within the basement, which supported the Level 1 floor framing, was observed to be deteriorated, including rot, and portions were unsupported. Adjacent to the wall, a section of wood framing, which comprised the basement floor structure and appeared in contact with the ground, appeared to have been recently replaced.

Within the mechanical room, the floor below the water heater appeared to be deflected and locally fractured. The full extent of deteriorated floor structure and load bearing elements was not confirmed at the time of our assessment due to concealed conditions and limited finish removals.

On Level 1, the floor within the kitchen was observed to be locally deflected. This deflection was generally commensurate in location with the unsupported load bearing wall below.

The integrity of select structural elements was locally compromised, and as a result may be prone to additional damage, including a sudden and localized collapse. Should access be required to or through the area, we recommend the immediate application of emergency measures to stabilize it. The emergency measures would comprise shoring elements.

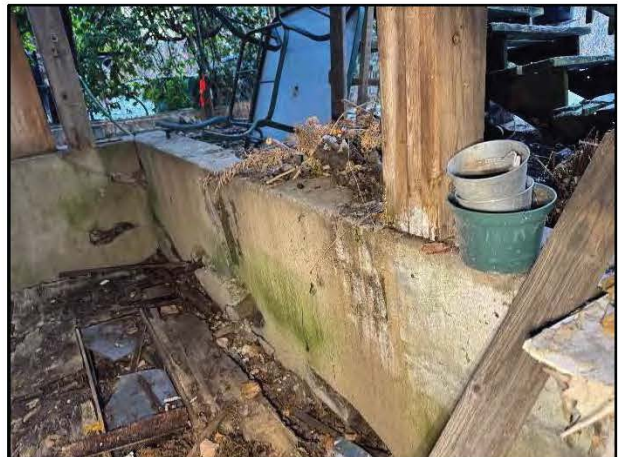
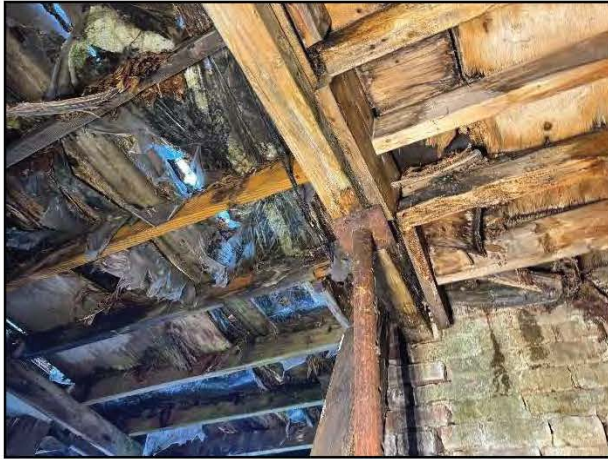
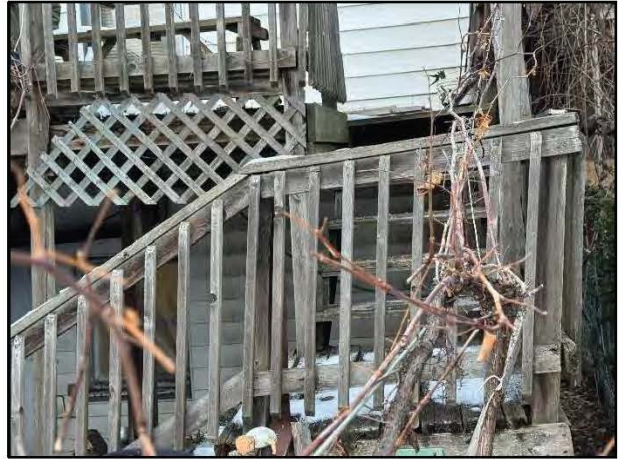
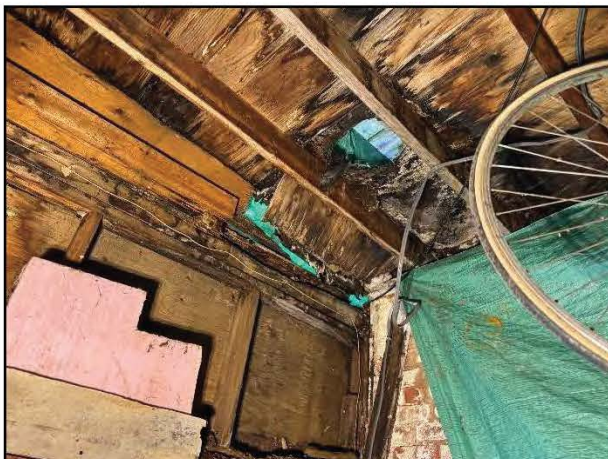
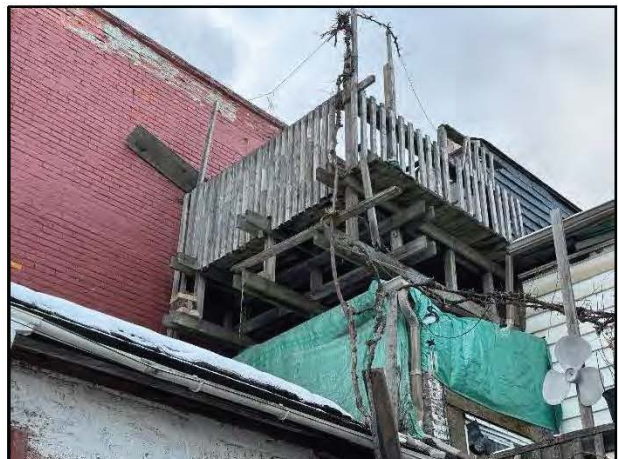
3) The East Deck Structure

The raised two tier deck and its structural elements, including deck boards, joists, beams, and foundation elements, were observed to comprise an unconventional construction methodology with severe deterioration and displacement.

The structural integrity of the deck along the east elevation was compromised, and as a result may be prone to additional damage, including a sudden and catastrophic collapse. To safeguard the health and welfare of the public, we recommend it be immediately demolished. The rear yard, inclusive of the deck, shall be cordoned off with no access until the above referenced demolition is complete and the remaining structure reviewed by the municipality. Prior to the demolition, we

recommend access from the dwelling be restricted. Furthermore, we recommend that the city assess the reduced egress requirements, installing supplemental stairs if and as required.

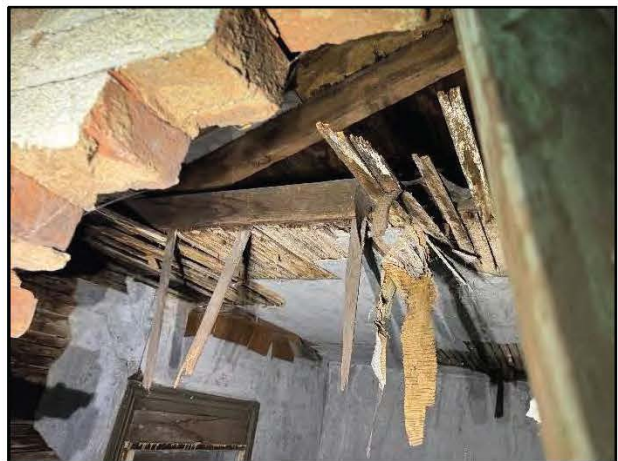
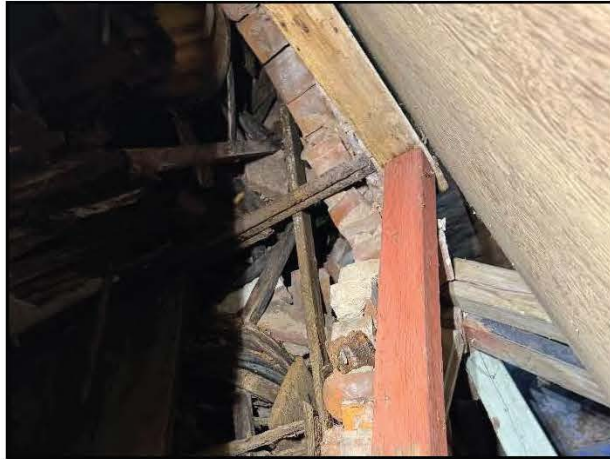
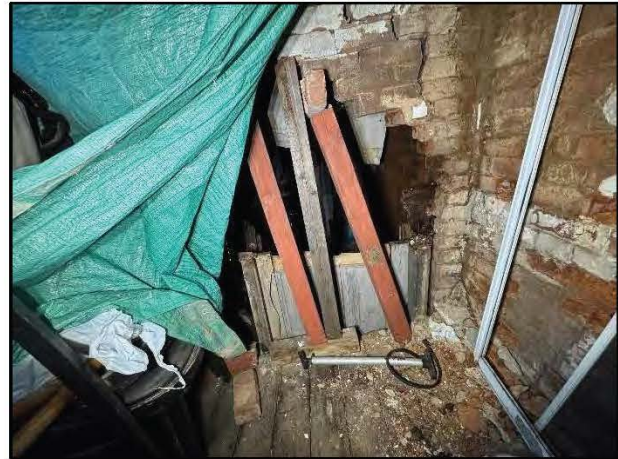
4) East Wall of Shed

The east perimeter wall of the shed, which comprised the gable end, adjacent to the dwelling, was observed to be partially collapsed. Temporary bracing and stabilizing elements had been installed reportedly by the occupant. Select temporary elements were supported by the deck. We were not provided access into the shed, and observations were made from the available vantage points.

Compensating stabilization measures are recommended prior to, or concurrent with, the

above recommended deck demolition as it appeared the existing temporary supports relied on the deck for stability. Depending on contractor means and methods, this could include temporary shoring or localized controlled removals of unstable brickwork under an engineer's supervision.

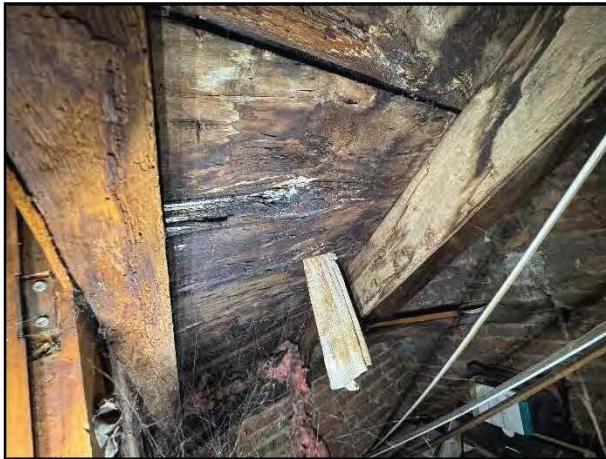
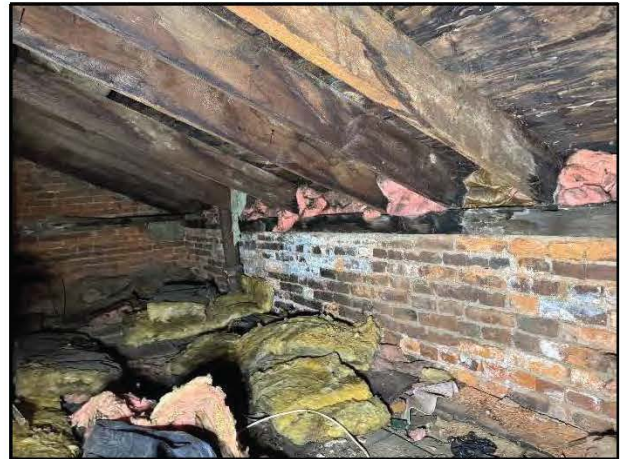
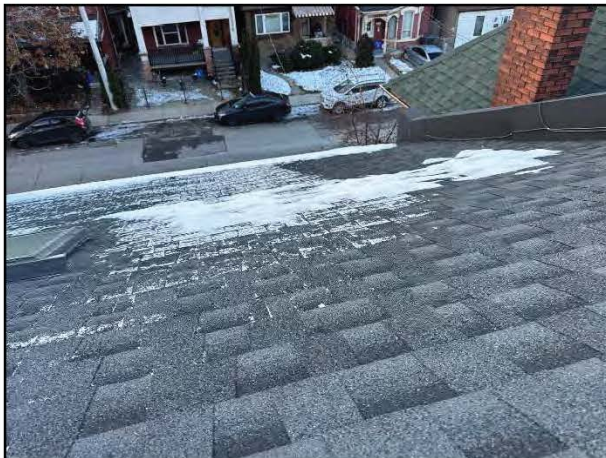
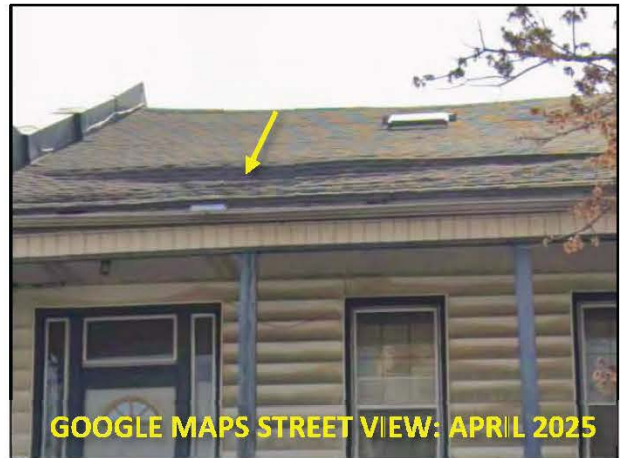
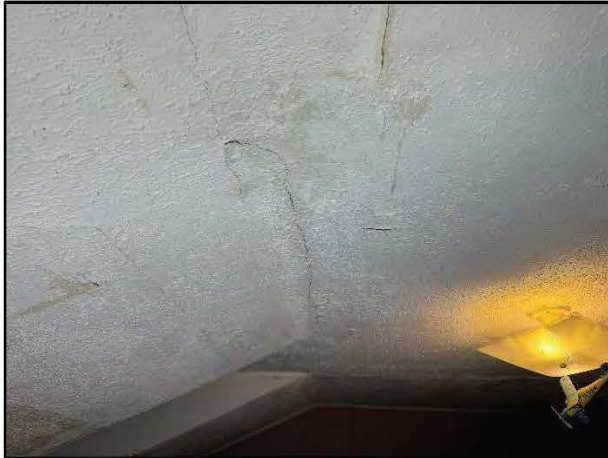
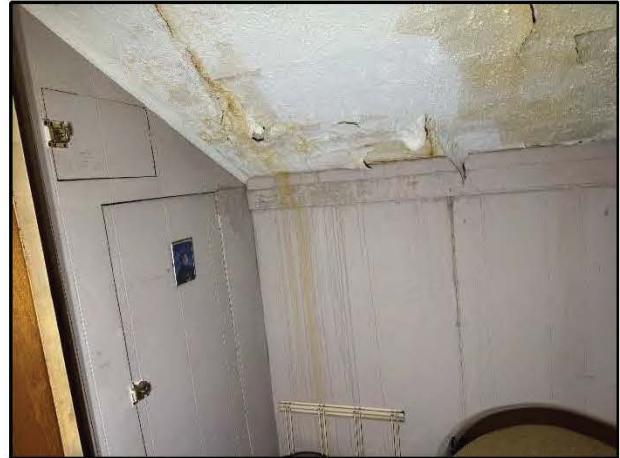
5) Roof Condition

At the time of our attendance, there was no access into the upper attic section nor the east knee wall section. We did however have access into the west knee wall area. In addition, snow accumulation at the time of attendance obstructed views of certain exterior roof areas, specifically near the front porch.

Within accessible roof areas, the condition of roof members appeared commensurate with the building age, and deterioration of plank board sheathing was observed. Ongoing water ingress was reported during heavy precipitation events, consistent with the observed damage to the interior finishes. Paint blistering, moisture staining, and hairline plaster cracking were observed at collar tie to rafter connection areas along the west pitch.

From the exterior, the roof ridge was observed to demonstrate localized downward deflection.

Photographic evidence from Google Street View dated April 2025 depicted that the presumed rafter connection of the front porch roof to the west perimeter wall, at the lower extent of the west pitch, appeared to have potentially locally failed. Multiple photographs across different historic dates suggested the depression at the front porch roof area had been exacerbated over time. At the time of our attendance, snow accumulation covered the lower extent of the west pitch above the front porch, and the roof depression was not visible from exterior vantage points.

Further assessment of the upper roof ridge area and porch rafter conditions is recommended. Further assessment would require selective removal of ceiling plaster at the upper level to review rafter conditions in the upper attic areas, as well as removal of the front porch soffit to review porch rafter conditions and the connection to the perimeter wall.

Based on the observed peripheral damage and the information available at the time this report was prepared, we recommend that the front porch be cordoned off (or shored/stabilized if access is required) until further assessment of the concealed components can be completed and the structural stability confirmed, with any constituent structurally compromised elements being repaired or shored, as necessary.

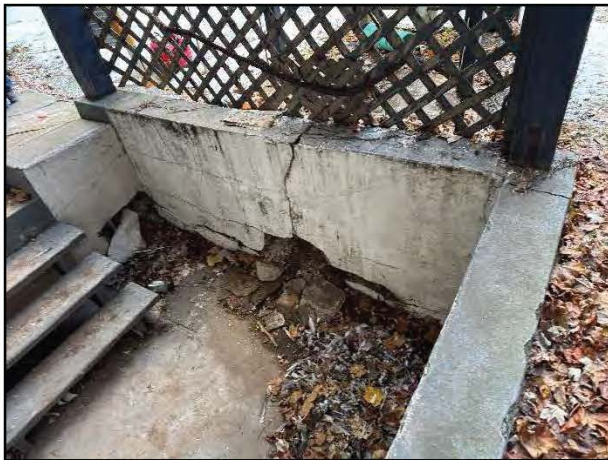
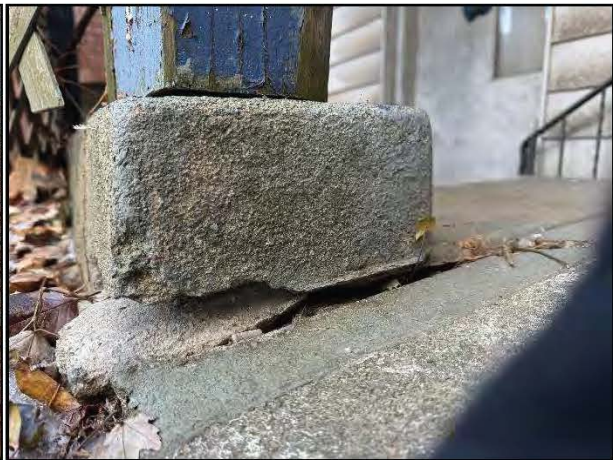
6) West Retaining Walls

The concrete retaining walls supporting the front porch were deteriorated and locally displaced. Despite this, we observed no evidence to suggest these elements were at risk of imminent collapse. We recommend the concrete foundations be repaired or shored promptly to eliminate the potential for additional damage.

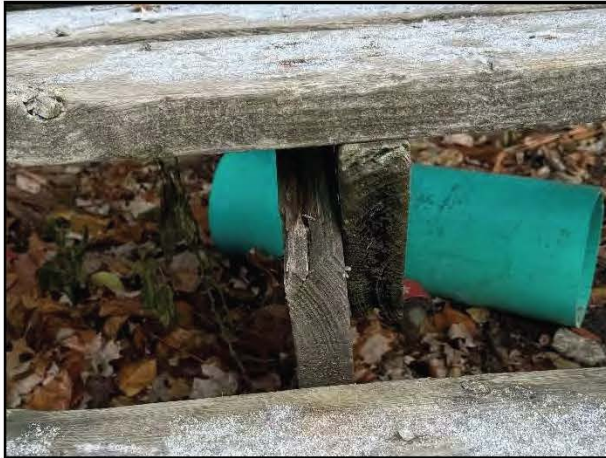
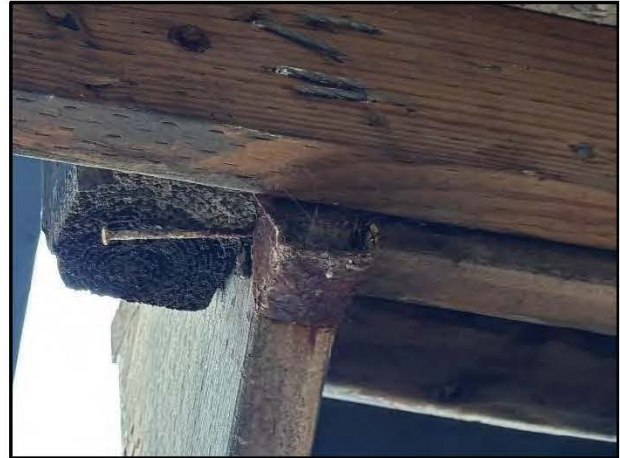
7) Front Porch Steps

When walked upon, the front porch steps from grade to the upper level exhibited deflection. Select mid support columns appeared raised and unsupported above the precast concrete pads below. Stringer joist hangers appeared significantly corroded. Select tread nosings were partially unsupported and deflected under foot pressure.

We recommend localized repairs be completed promptly to avoid potentially hazardous conditions to the public.
