HERITAGE IMPACT ASSESSMENT

13004 | Tivoli Theatre (108 James St. N)

Review of Existing Conditions
and
Proposed Stabilization Work

The Tivoli Theatre

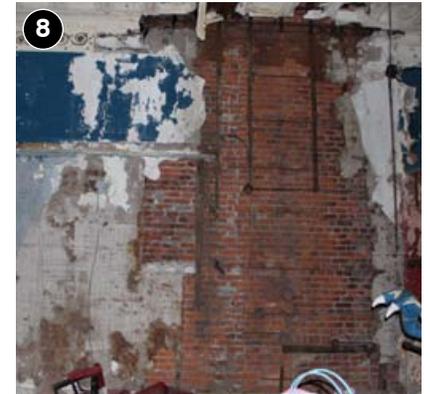
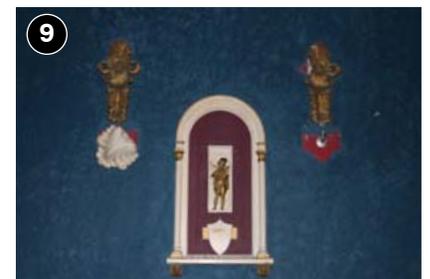
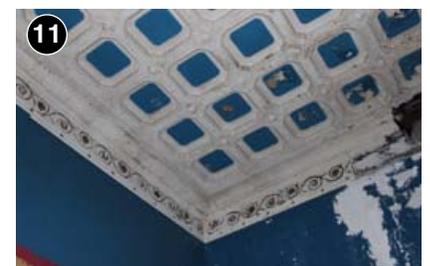
Conditions of Lobby

- 3.1.1 View of Lobby
- 3.1.2 Exposed brick behind deteriorating plaster
- 3.1.3 Plaster decorative wall niches on wall - showing wear and tear of chipped paint and plaster
- 3.1.4 Plaster Wall medallions spray painted gold
- 3.1.5 Plaster coffered ceiling - some areas show signs of deterioration and water damage.

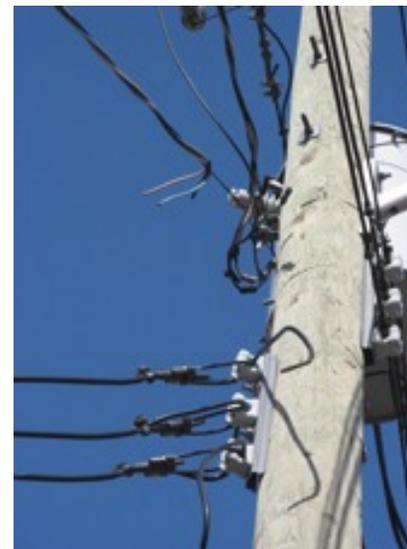
Detail at hydro pole showing service to building cut off, wires cut at pole

We were informed, and observed that there are currently no energy services to the building, both electricity and gas services have been cut off.

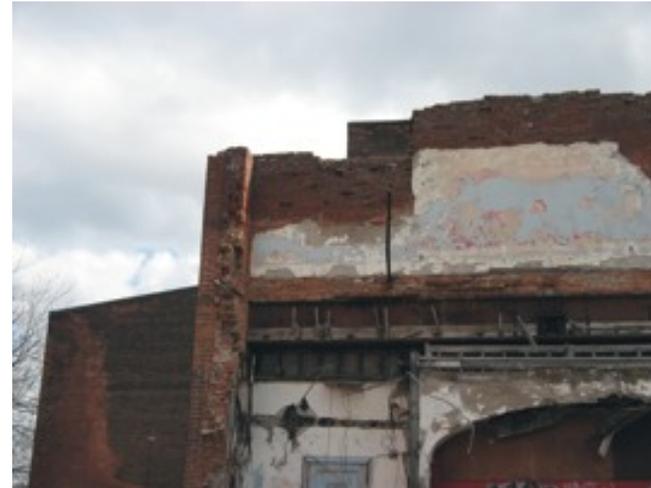
Detail at concourse, no roof flashing or roof seal at concourse

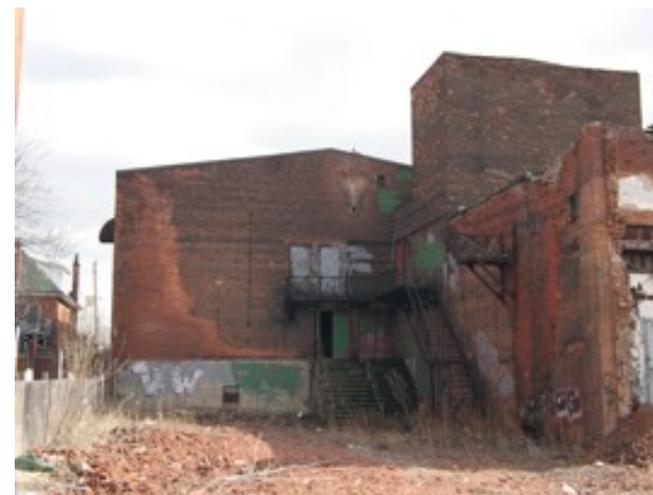
This overflow water has severely damaged a considerable area of decorative plaster and paint finish in several locations in the building interior.

West end of auditorium house, staining indicates where water flows off flooded roof. This also flows to the interior under the roof flashings

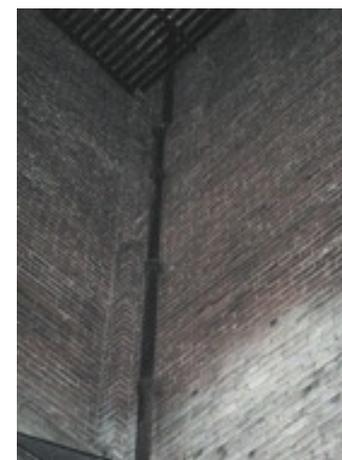
Rainwater leader from high roof at stage house. 6 Rainwater leaders (RWL) require heat tracing to prevent icing in winter.

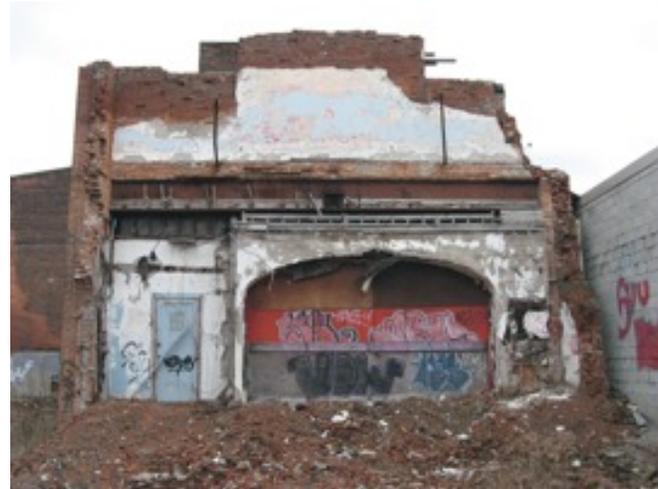
The primary entrance point is the cut off line of the concourse at the west end of the remaining building. The closure of this hole is poorly constructed and is admitting water to this end of the concourse. This permits further damage directly through the action of the water, but also introduces much more humidity into the building.

Detail at cut of concourse, a new exterior wall is required to seal this location against weather and vandals.

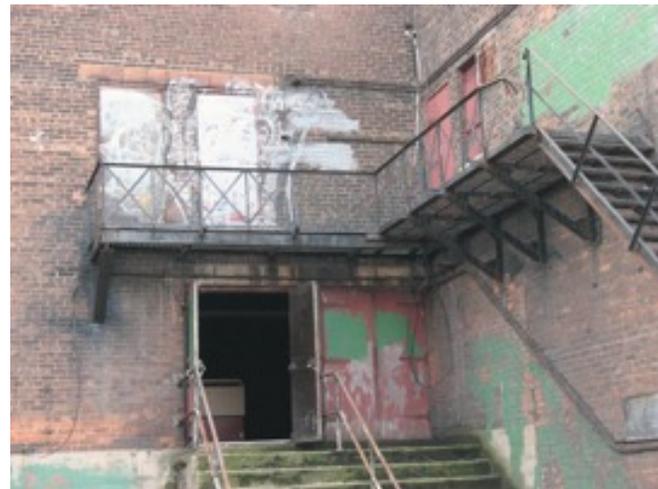
Doors to auditorium and projection room. These should be sealed up, use concrete block or brick which may be removed in future.

.2 We recommend that only one man door and one service door remain operable. These would be the doors on the east end of the building to the stage on Houghton Street.

.3 All other doors should be blocked up to prevent vandal entry and to seal them against the weather.

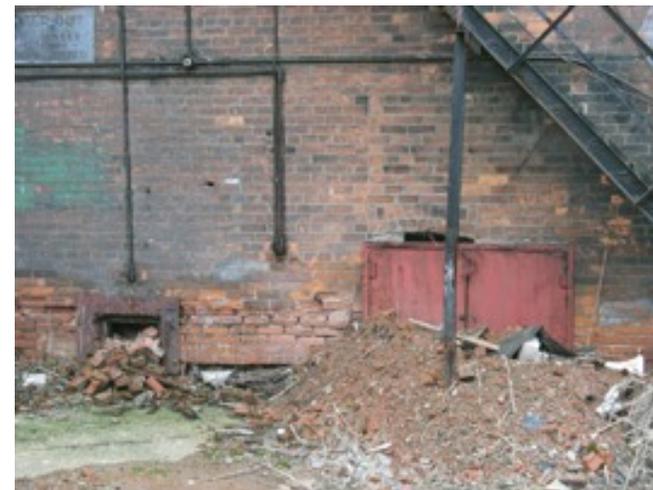
Detail at north wall of concourse, note open hatch to crawl space admitting water and vandals, partially blocked by loose masonry at present.

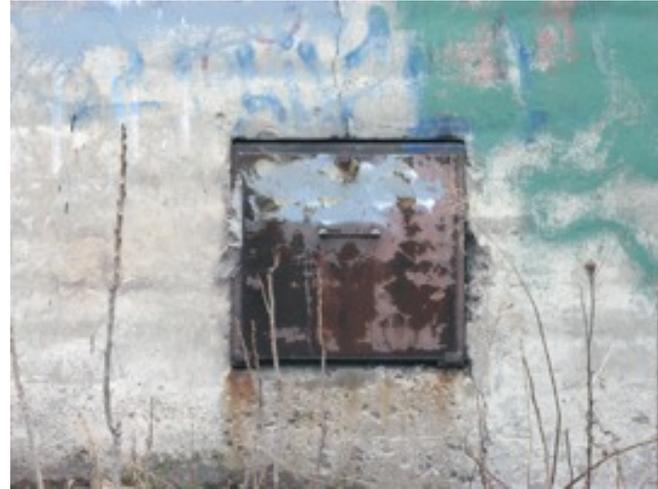
Example of access hatch. There are several around the building. An attempt to pry this open is apparent. These should be further secured and sealed against the weather.

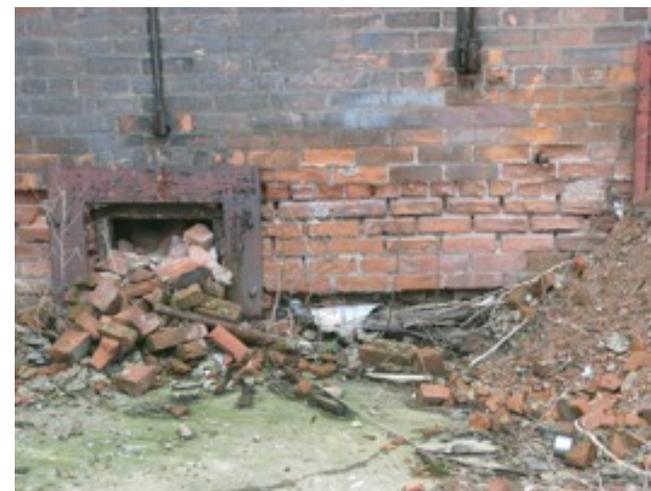
Detail at north wall of concourse. The brick masonry is severely deteriorated in this area and one full wythe of brick is missing. Joints should be pointed and missing brick replaced.

.1 The areas of brick repair noted above should be attended to for both building stability and as a safety measure against falling bricks. **The upper level work should be undertaken as soon as possible as a hazard exists to pedestrians below from falling brick.**

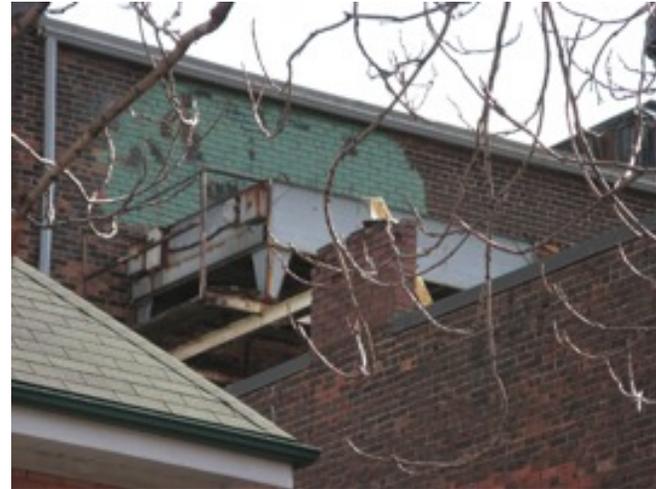
Detail of brick pier at north side of auditorium. This supports roof top equipment and should be repointed and missing bricks replaced.

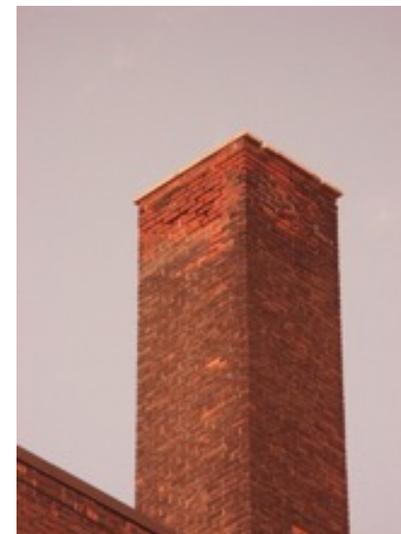
Detail of badly deteriorated chimney at the north east corner of the building. This poses a hazard to the street below and should be pointed or rebuilt at its top as soon as possible

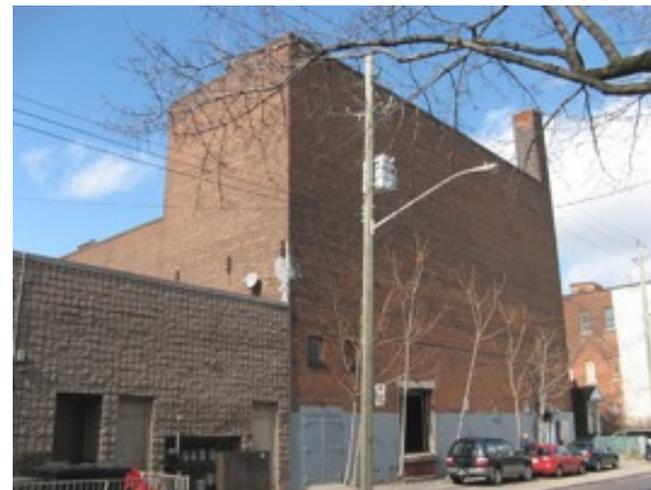
General view of east wall. Note location of deteriorated chimney

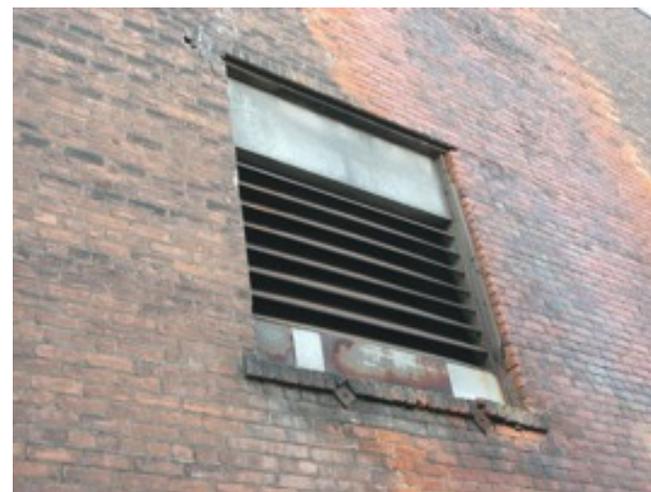
Detail existing Grille on north wall. This can be used to ventilate the interior

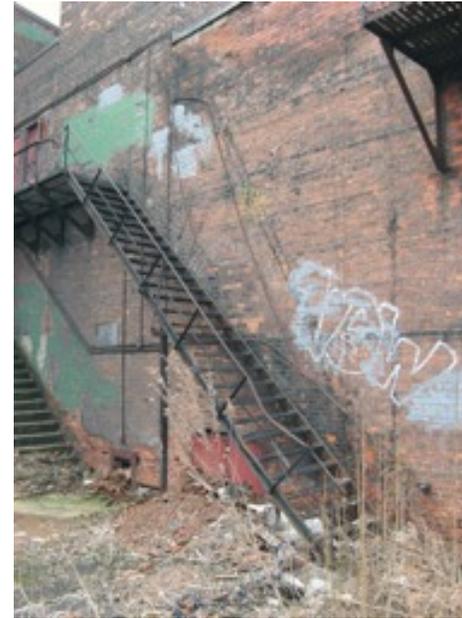
View of fire escape stair on north side of the concourse. This should be removed as it permits vandals to reach the roof areas above.

.5 Vandal access to the roof areas is supported by an existing fire escape stair on the north side of the concourse. This should be removed. A ladder should be purchased and be locked up inside for maintenance access.
