HERITAGE IMPACT ASSESSMENT

13004 | Tivoli Theatre (108 James St. N)

Review of Existing Conditions
and
Proposed Stabilization Work

The Tivoli Theatre

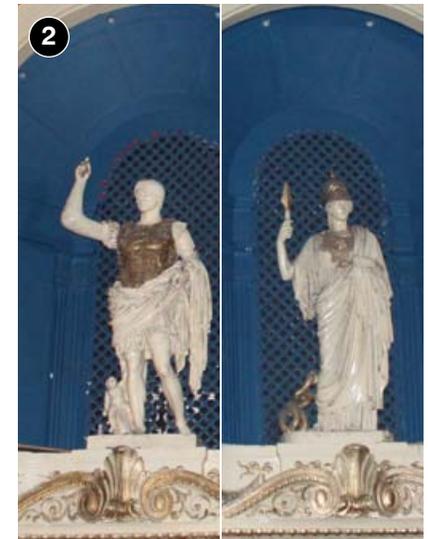
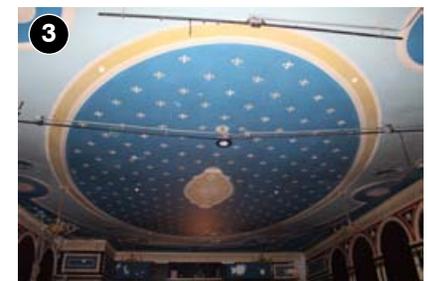
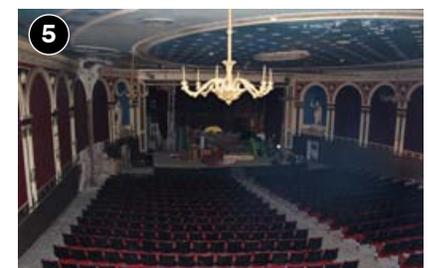
Auditorium Features

- **Structure, Masonry:** *Currently in fair condition, but requires some repair.*
- **Roof Assembly:** *According to the 2007 inspection, the roof leaks and requires replacement. In 2010 some stabilization work was undertaken. Downspouts were noted as cracked and leaking on the site.*

- **Door and Windows:** *Require replacement and security hardware.*
- **Walls:** *Plaster Finish - isolated to extensive repairs are required*
- **Heating / Air Conditioning:** *no system exists on site*

- **Electrical , Plumbing:** *New upgraded systems required.*
- **Code Compliance:** *Requires building and fire code upgrade such as sprinkler system, fire exit adjustment, fire alarm systems, fire curtain repair, barrier-free access, hazardous material abatement (if any).*

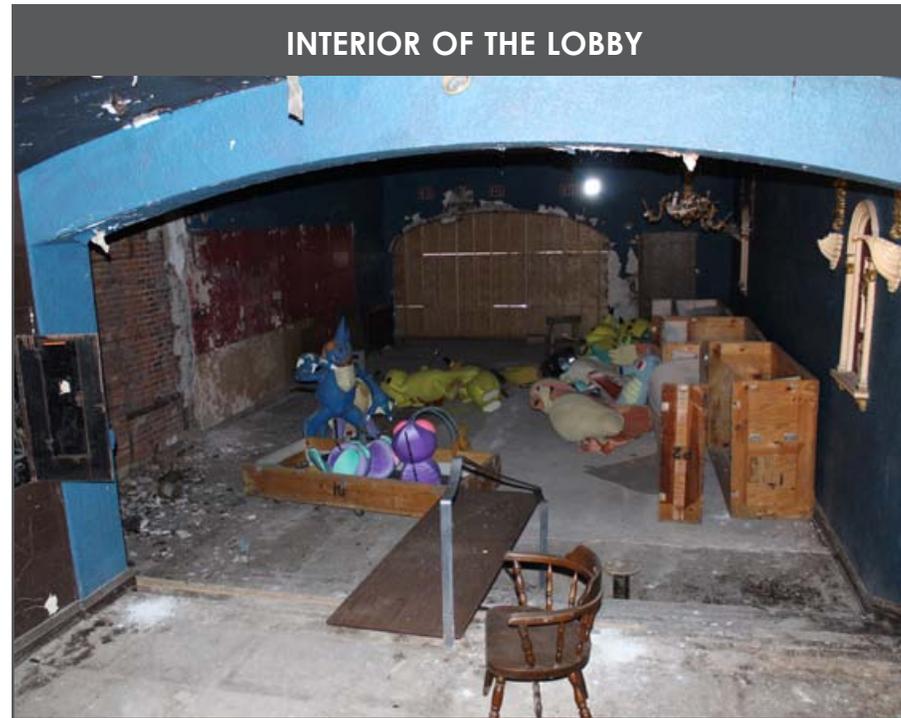
- 3.1.1 View of Lobby
- 3.1.2 Exposed brick behind deteriorating plaster
- 3.1.3 Plaster decorative wall niches on wall - showing wear and tear of chipped paint and plaster
- 3.1.4 Plaster Wall medallions spray painted gold
- 3.1.5 Plaster coffered ceiling - some areas show signs of deterioration and water damage.

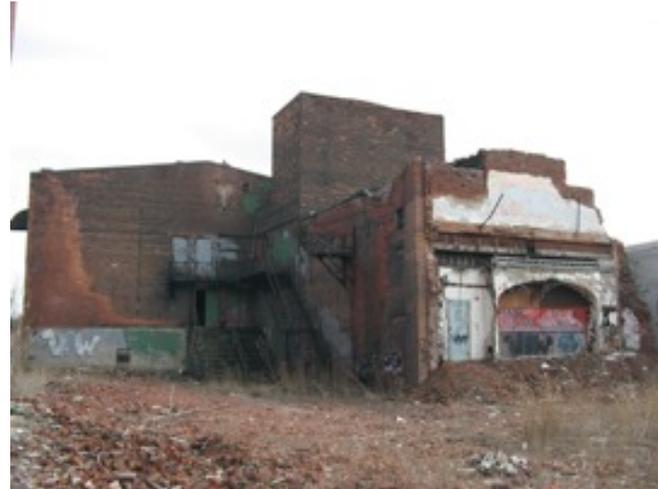
West elevation of remaining building showing concourse cut off with auditorium house beyond

.1 We recommend that a more substantial closure wall be constructed to seal off the cut line of the concourse. This new partition should be constructed of metal studs affixed to the exterior of the existing structure to shed water beyond the walls and floors that remain. At its top it should be sealed and flashed to the existing roofing system and it should be sealed at its perimeter to the remaining walls. The partition exterior should be an exterior grade cement board or heavy plywood, painted, on a water repellant air barrier on steel studs. Insulation should be installed and this held in place by 6 mil ploy and drywall. It is not necessary to tape the drywall. No interior finish is required.

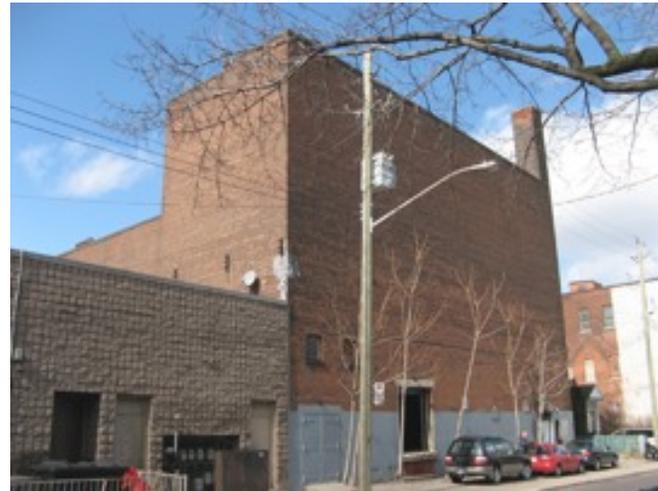
East Elevation, rear, of the building showing stage house

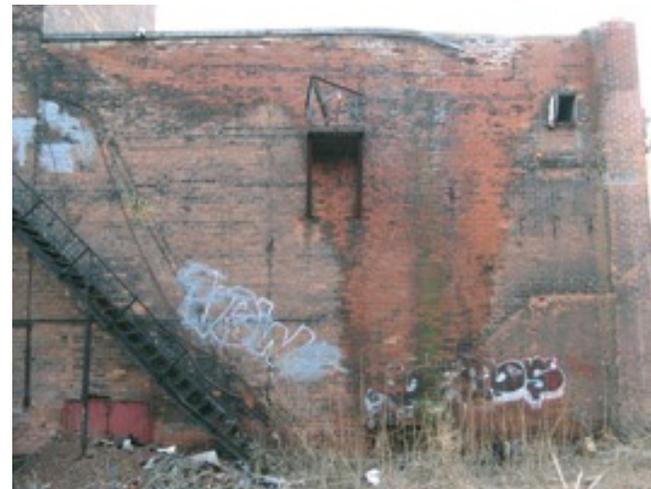
North Side of concourse, not roof flashing ripped off at west, right, end of roof

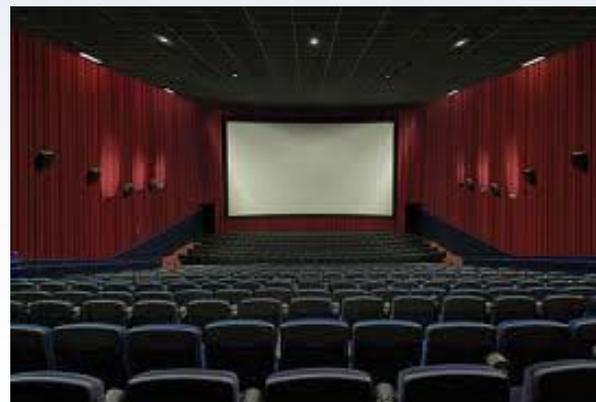
Poor sightlines at the rear of the Tivoli auditorium
